# Potawatomi State Park

## Tree Clearing & Master Plan Compliance Report

Prepared May 2026 | Source: 2018 Northern Lake Michigan Coastal Regional Master Plan (WDNR)

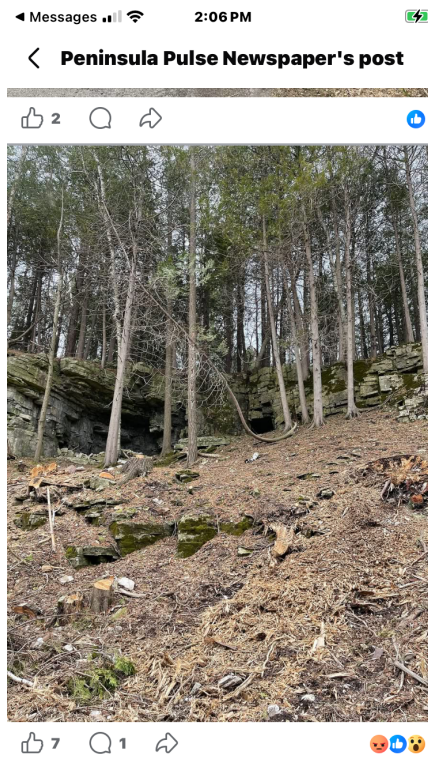
### Photo 1: Niagara Escarpment Bluff — Limestone Cliff Face

Potawatomi State Park bluff face showing limestone cliff and cedar trees. Source: Peninsula Pulse Newspaper / Facebook.

**Eastern Red Cedar / Northern White Cedar** — The tall, columnar trees growing directly from the limestone face. These are the most critically protected species under the master plan. The plan notes

that cedar trees on the Niagara Escarpment grow at only one inch every 15 years; a single northern white cedar in Peninsula State Park was aged at over 500 years old.

**Mixed understory conifers** — Likely white cedar and balsam fir in the talus slope areas below the cliff face. The plan identifies these as part of the Northern Wet-mesic Forest community requiring passive management and no disturbance.

**Substrate:** Niagaran dolomite limestone — the bedrock of the escarpment, listed as globally significant habitat in the master plan.

This location falls within or immediately adjacent to the Niagara Escarpment Native Community Management Area. The master plan is explicit:

"Within a 200-foot buffer zone of the escarpment face, do not conduct management or development (e.g., timber harvesting, new parking lot or building construction), or allow uses that would disturb soil and forest canopy cover and negatively impact the core habitat area of the Niagara Escarpment."

■ PATCH contends that tree cutting shown here violates this 200-foot buffer zone requirement.

1. The 2018 Northern Lake Michigan Coastal Regional Master Plan designates the Niagara Escarpment as a Native Community Management Area with a strict 200-foot no-disturbance buffer zone. Tree cutting visible in Photo 1 appears to violate this buffer.

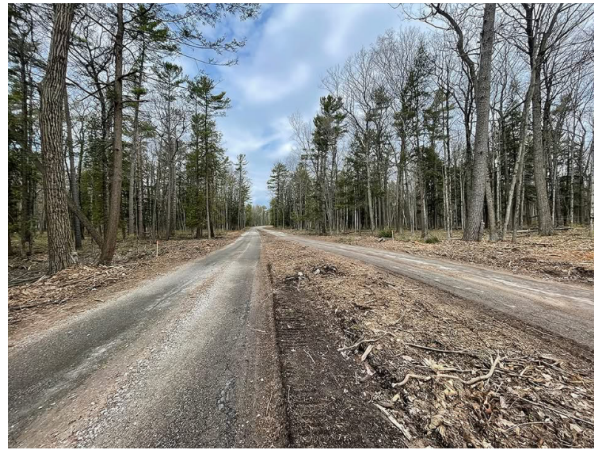
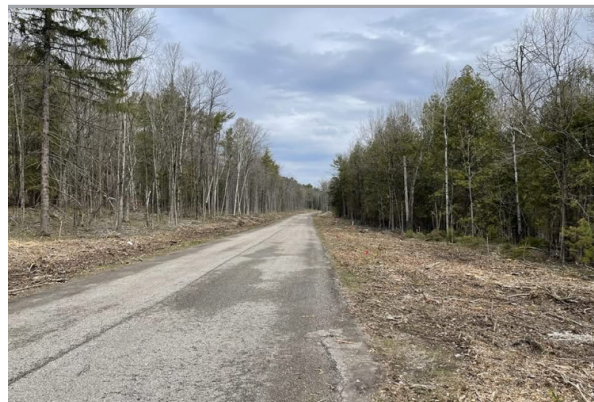
## Photo 2: Road Corridors — South Norway Road / Shoreline Road

Two views of cleared road corridors at Potawatomi State Park showing removal of roadside trees and understory.

**Trembling Aspen / Bigtooth Aspen** — Pale-barked trees visible on the cleared margins. Common in disturbed areas of the park's upland forest.

**White Birch** — Smooth, lighter-barked stems visible at the forest edge. Listed by the DNR as one of the dominant species covering Potawatomi's 1,200 acres.

**White Pine / Mixed Conifers** — Visible in the remaining tree line background, including what appears to be white pine and balsam fir.

**Stumps and slash piles** visible in foreground indicate recent clearing of trees that previously formed a canopy over the road corridor — described by park users as a "magical canopy" and important woodpecker habitat.

The DNR's own nature page describes Potawatomi's forests as composed of sugar maple, basswood, white pine, red pine, and white birch — the very trees cleared here. The master plan's Recreation Management Area prescriptions state:

"In forested locations maintain a healthy tree canopy. Where feasible, promote the growth and retention of larger trees."

The plan's short-term prescription for roads was to maintain existing facilities "at current development levels." The road-widening project — which the DNR listed only as "Road Resurfacing" in its 2025-26 Annual Property Implementation Plan — was not clearly authorized by any master plan language for tree removal at this scale.

2. The plan's short-term road prescription was to maintain roads at current development levels — not to widen them. No clear master plan authorization for large-scale tree removal along road corridors has been identified.
